Outer Harbor Pilot Cap

New Bedford Harbor Superfund Site

I. Overview of the harbor cleanup

II. The pilot underwater capping project

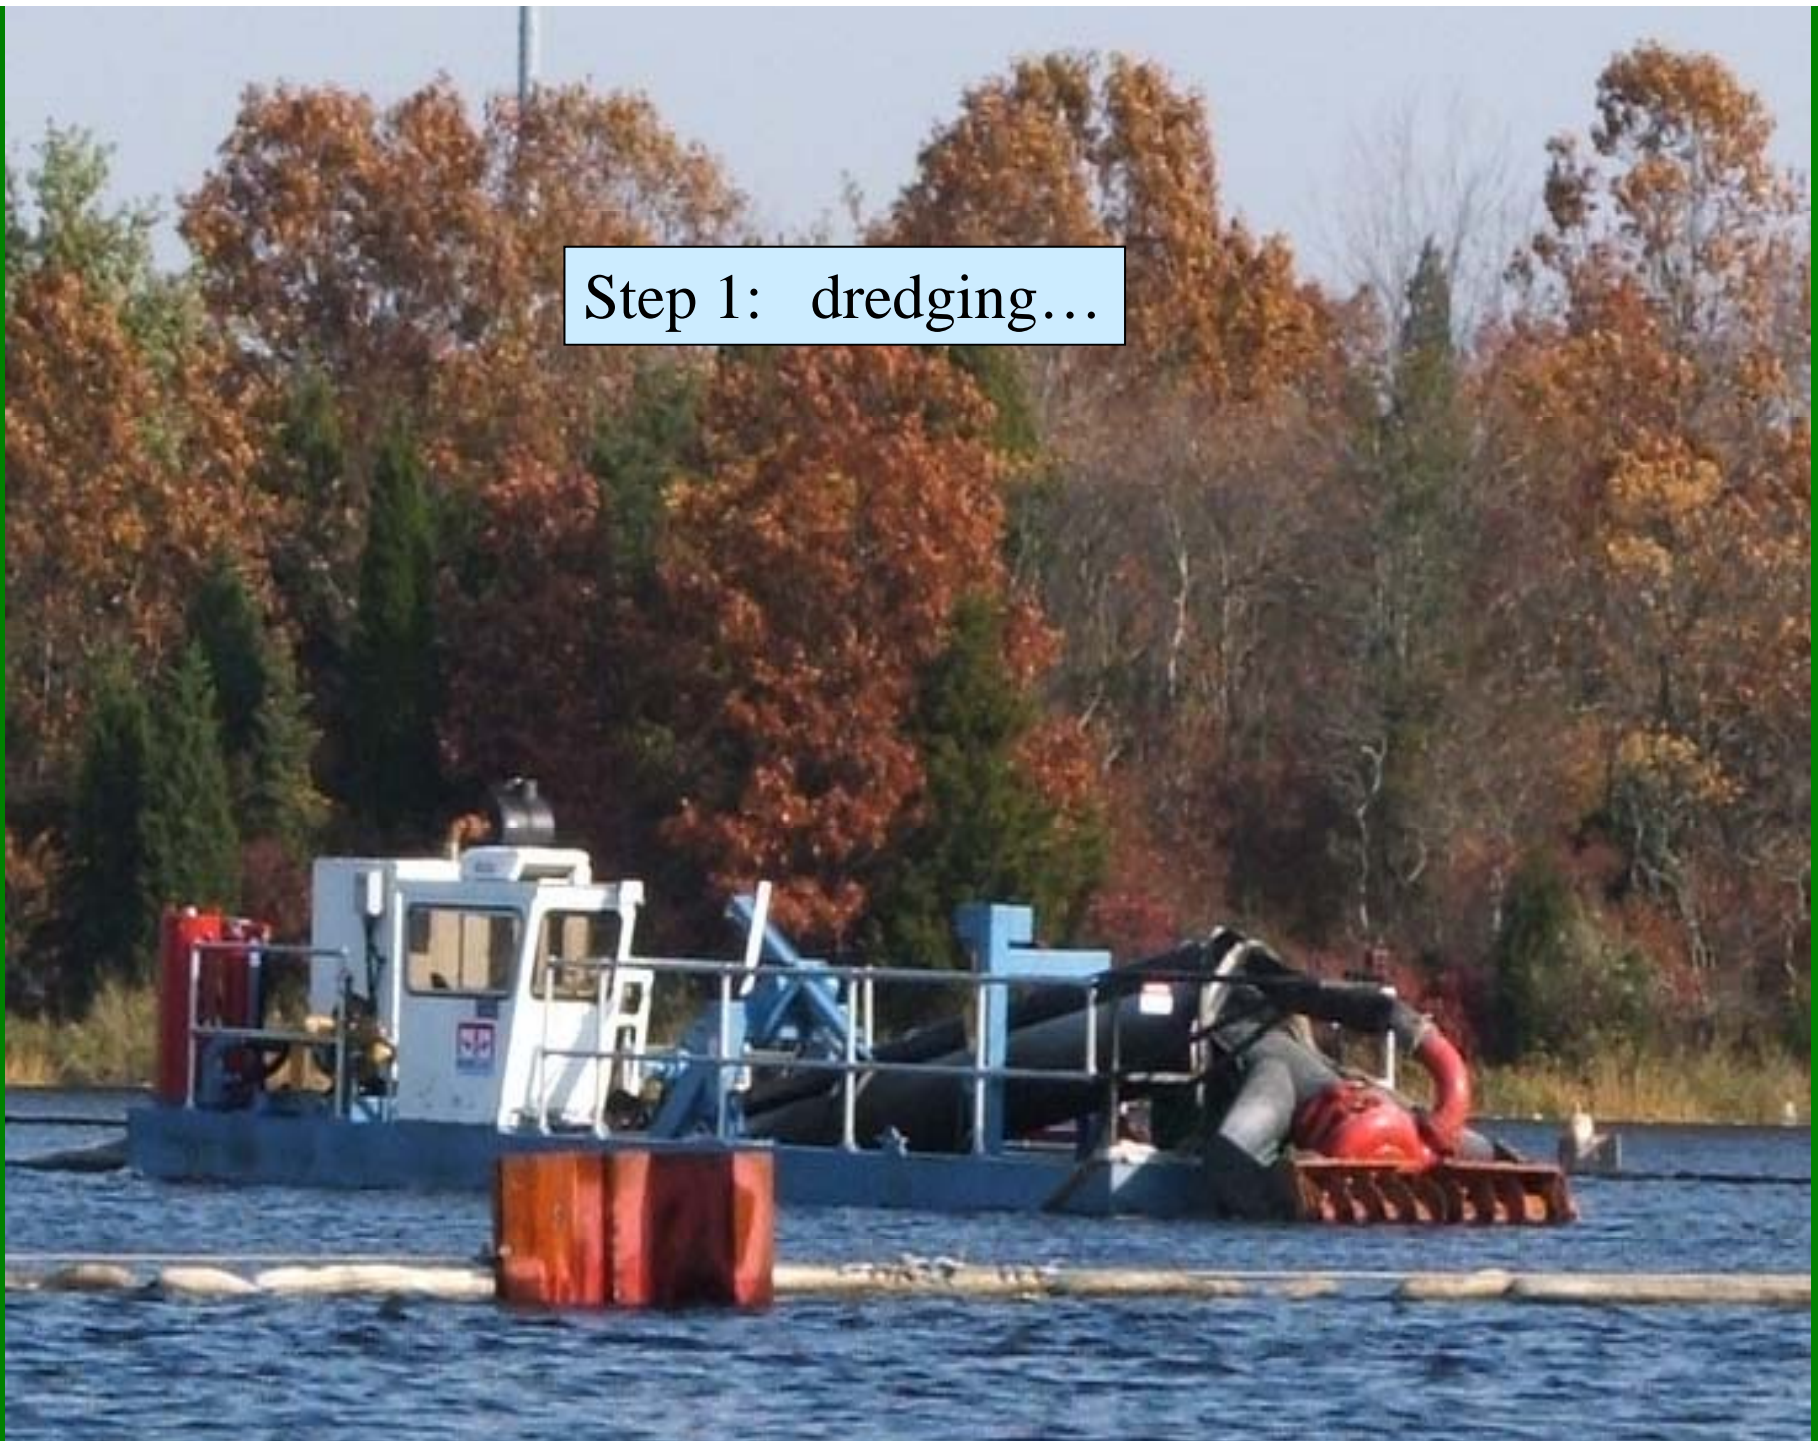
Step 1: dredging...

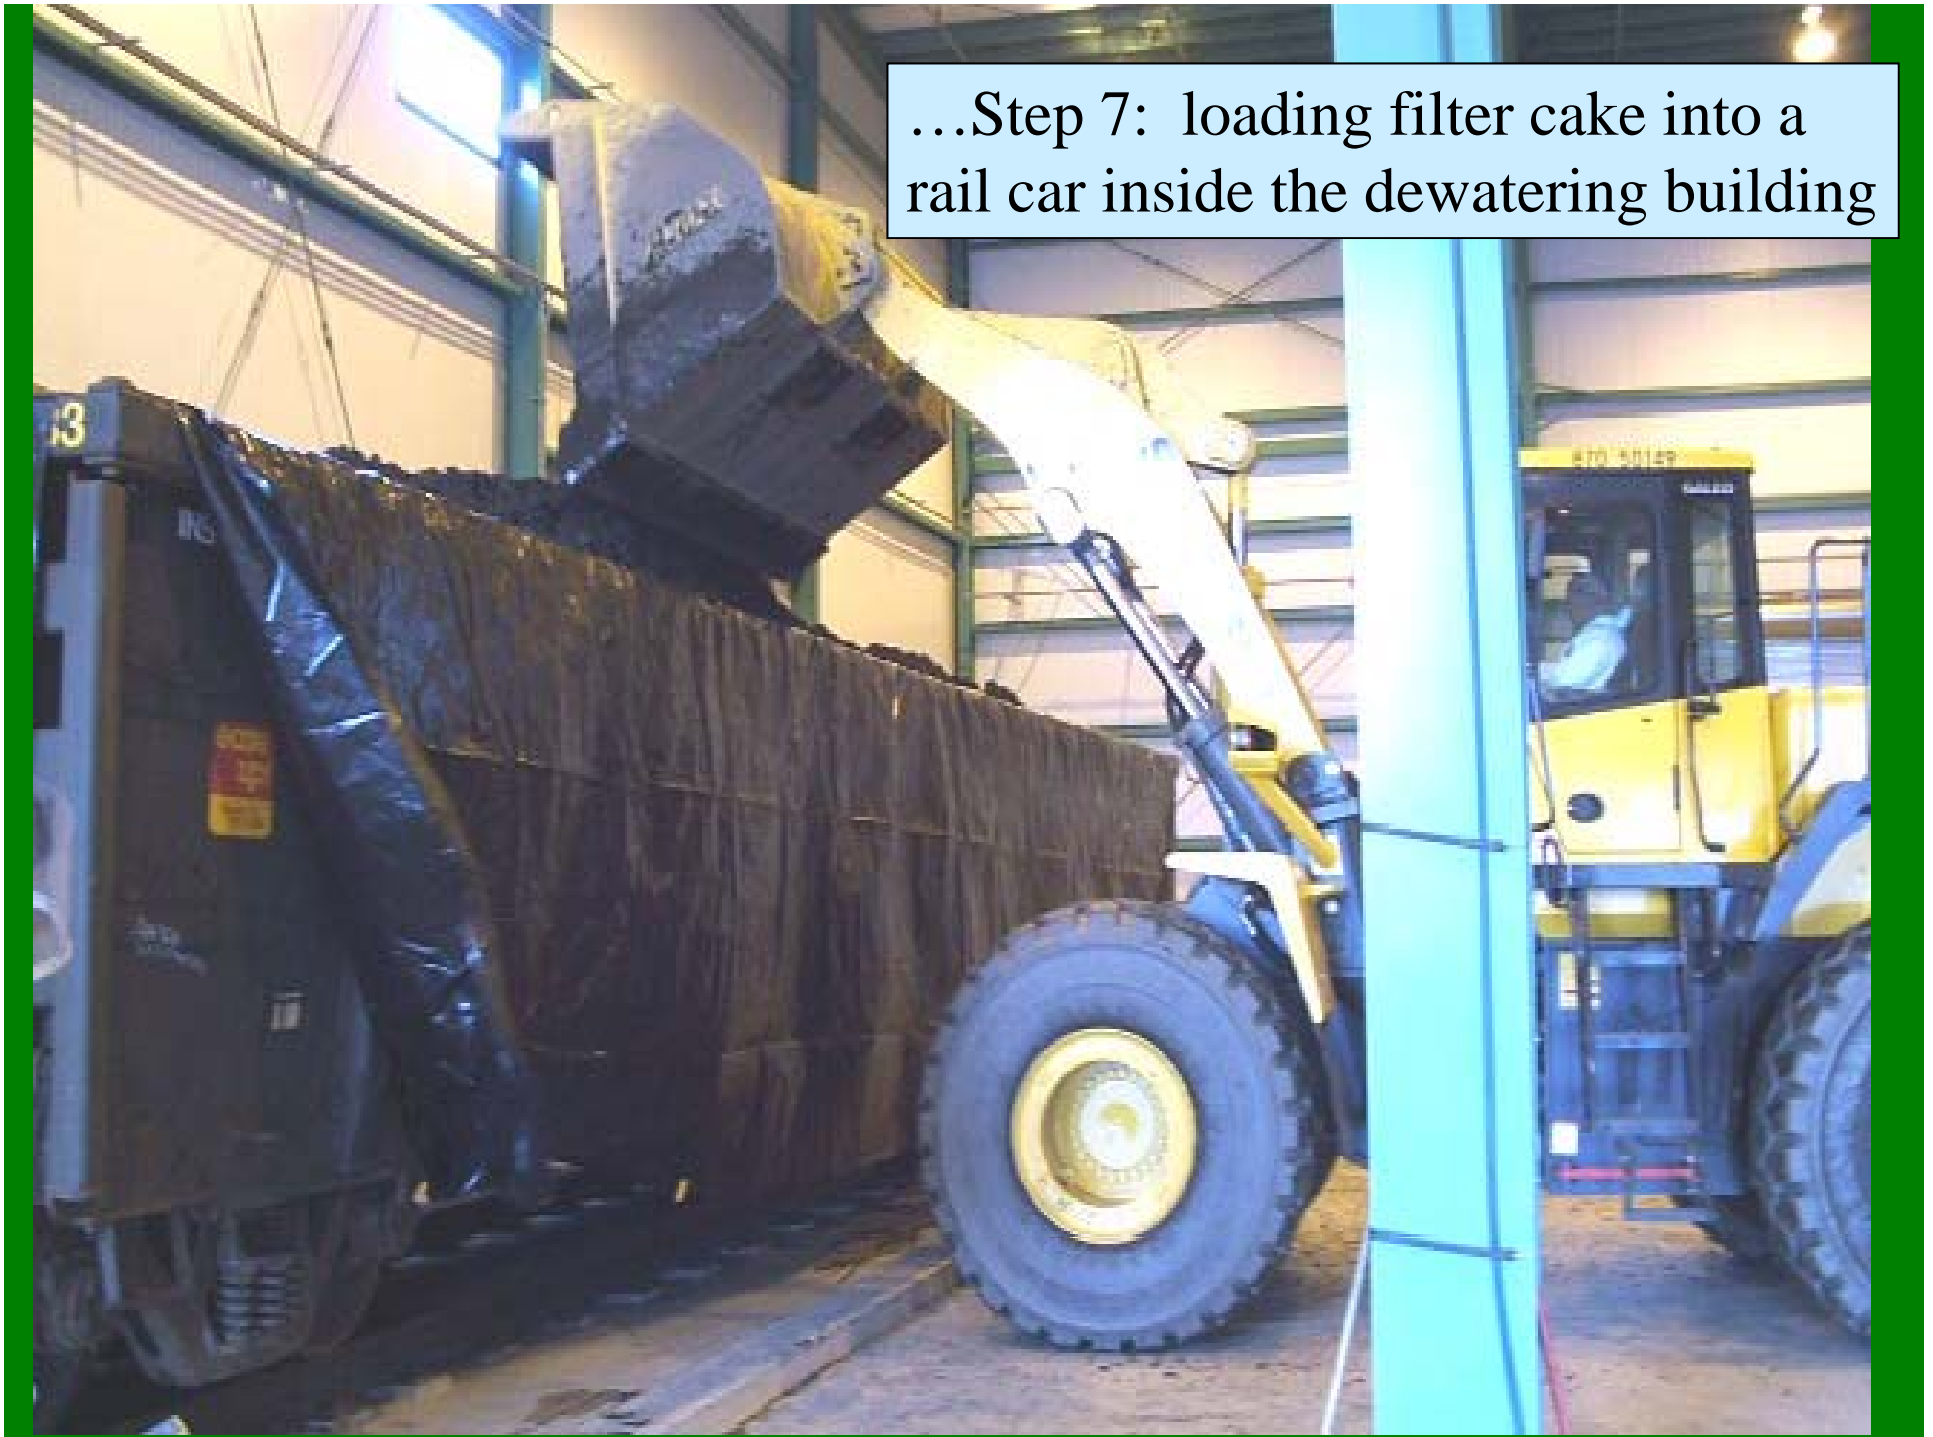
...Step 7: loading filter cake into a rail car inside the dewatering building

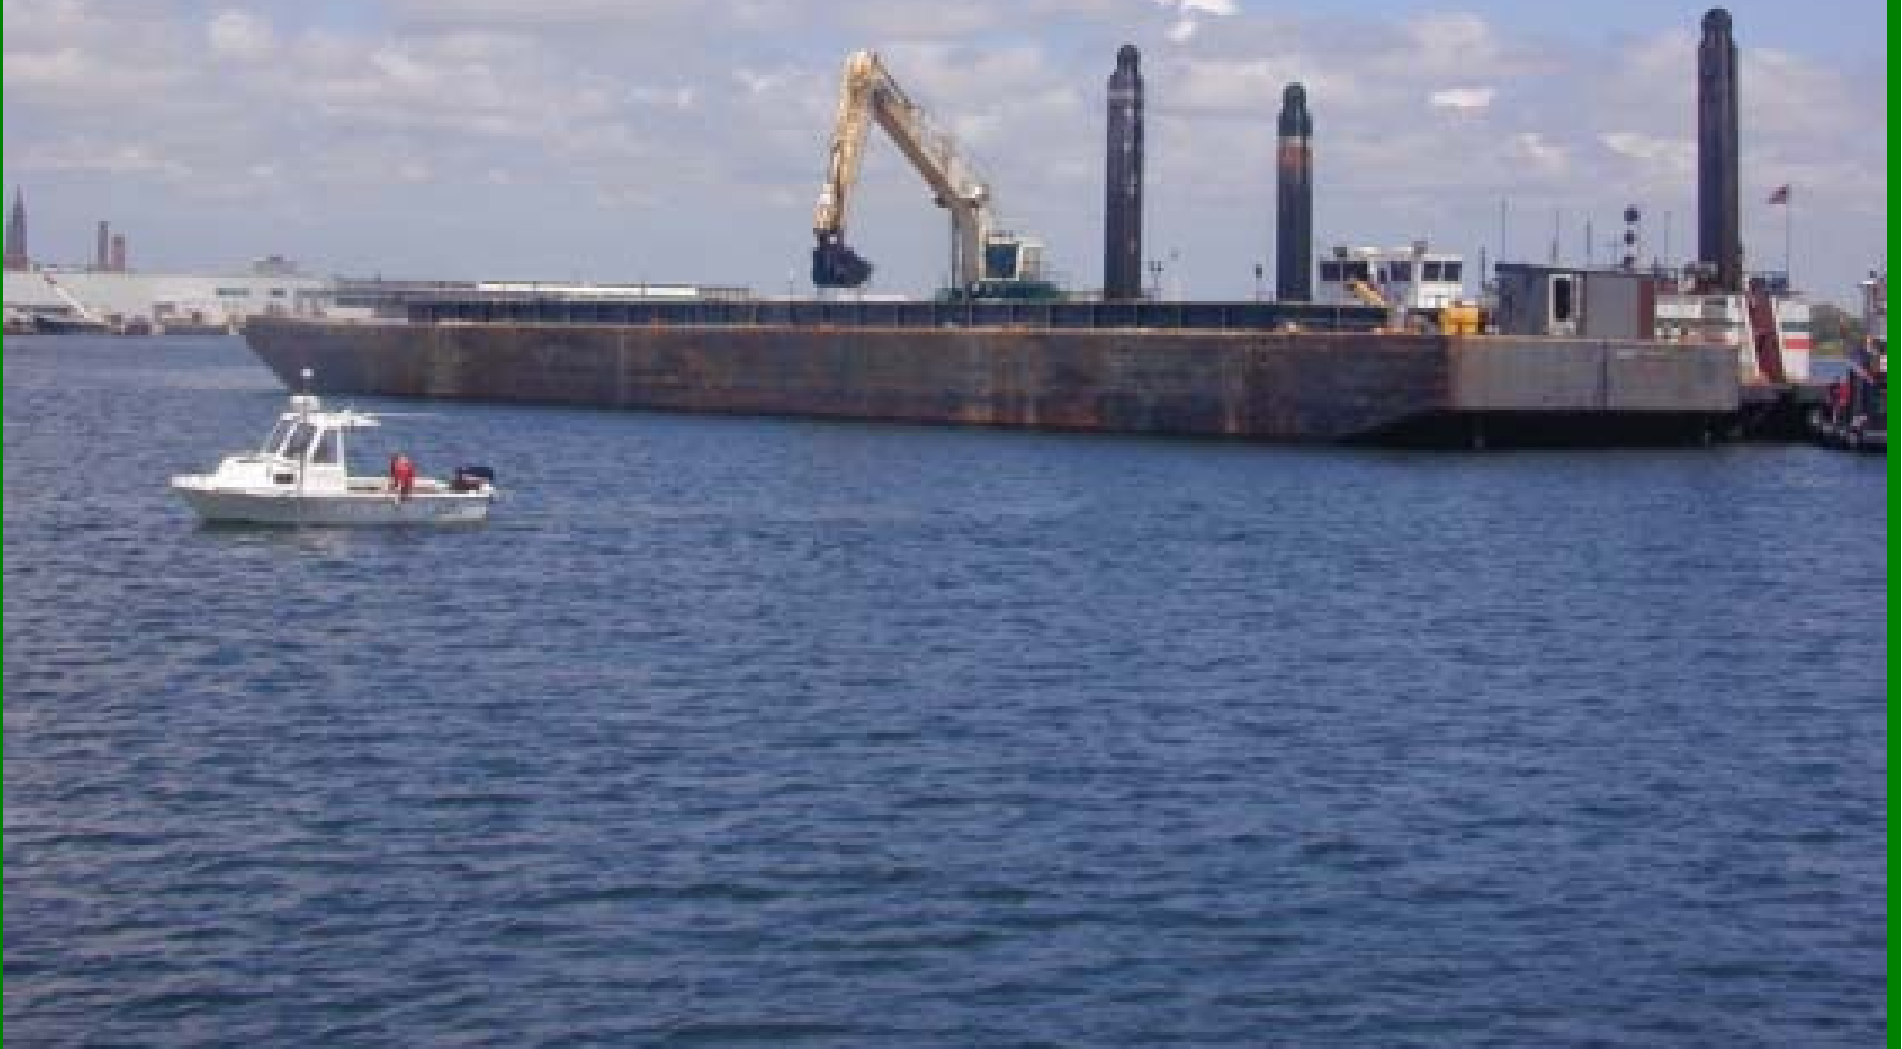
The port's CAD cell being excavated
